Power Quality Observations at a Light Industrial Site

Hamish Laird, *Student Member, IEEE*, Simon Round, *Member, IEEE*, Richard Duke, *Member, IEEE*
Alister Gardiner.

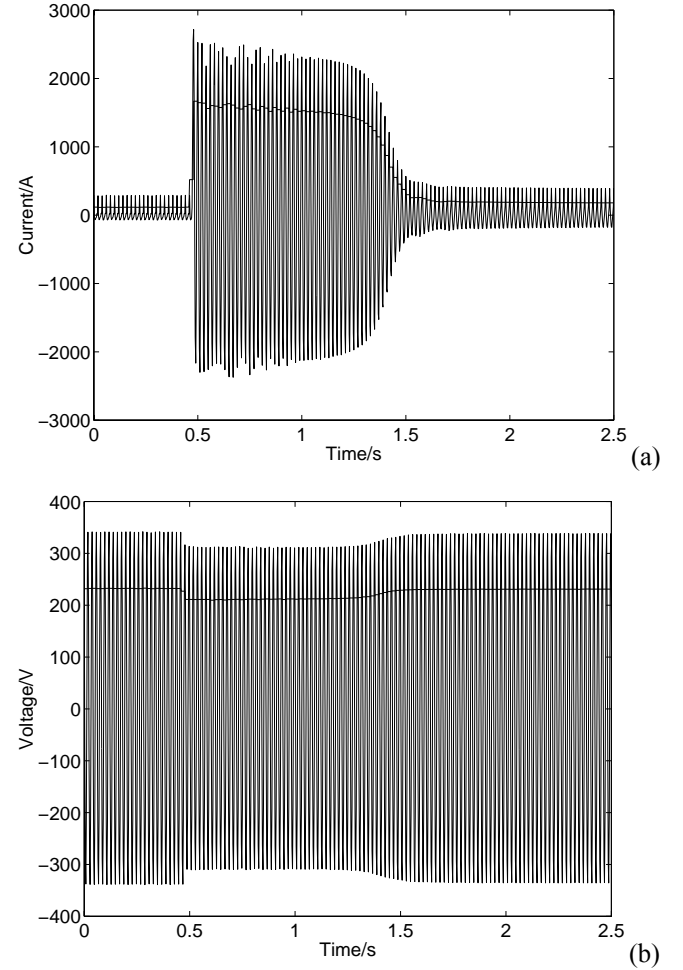
Figure 2. Induction Motor Start Transient (a) Motor Current (b) Supply Voltage (Instantaneous and RMS values)

water resistor starters to lower the start current. This large start current, Figure 2(a), causes a 10% drop in the supply voltage, (as shown in Figure 2(b)) which the customer has reported noticing as a flicker in the lighting.

The induction motor start transient typically causes a 10% drop in the site voltage. A solid-state or star-delta starter could lower the start current and so lower the voltage drop. The cost involved may not be justifiable as the motor start induced sag caused no reported problems other than the customer's concern about the "flick" in the lights. Another option to prevent the voltage drop is to control the motor run up with an adjustable speed drive. This again is an expensive option and is probably not worth pursuing. A more reasonable approach is to ensure the customer is aware of the possible consequences of the voltage dip, such as nuisance tripping and PLC malfunction. This awareness will ensure that any problems that the dips do cause will be noted.

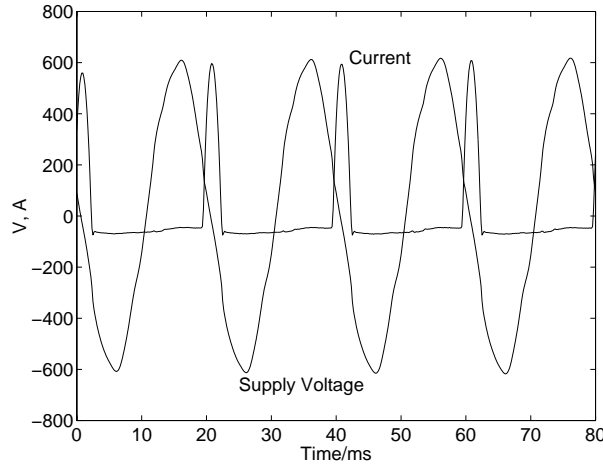
Figure 4. Induction Motor Heating Unit Current and System Line to Line Voltage

The units are half-wave controlled rectifiers having only one thyristor and they produce DC, odd and even harmonics in the AC current. The lack of half-wave symmetry indicates that there are even harmonics and a DC component present.

The induction motor heater unit current harmonics are large and the presence of even harmonics is unusual. The apparent lack of problems that the DC component of the heater current causes is perhaps fortuitous as the resulting transformer MMF offset could cause transformer damage through saturation. No such damage has occurred and the transformer operating temperature during the site survey was 38 C. The fact that the heater units operate only when the site load is low means any adverse transformer heating from saturation is offset by reduced heating due to the low load. Configuring the rectifiers to produce a half wave symmetric current waveform would eliminate the DC current produced by the induction motor heaters. One way to do this is to reverse the phase connection of one of the induction motor heaters. The two heater units would then conduct in opposite half cycles and together would produce a half-wave symmetric waveform. This would decrease the peak current and remove the even harmonic currents. The current waveform would however not be half-wave symmetric at all times as the heating units are on occasion operated separately. However the maximum level of DC current flowing in the transformer would be lowered as DC current would flow only when one heater was operating.

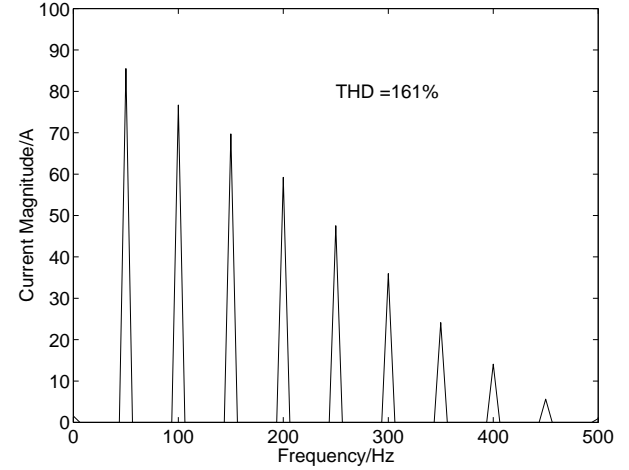
Figure 5. Induction Motor Heater Current Frequency Spectrum

The frequency spectrum of the heater current is shown in Figure 5. There is no DC component shown on the spectrum, as the current sensors are current transformers that are not capable of measuring the DC component. The presence of the DC current component was confirmed by on site measurement with a meter capable of DC current measurement. The even harmonic content is shown and the presence of these means that a system resonance at or near an even harmonic could be excited by this waveform. A current without even harmonics could not excite such a resonance.

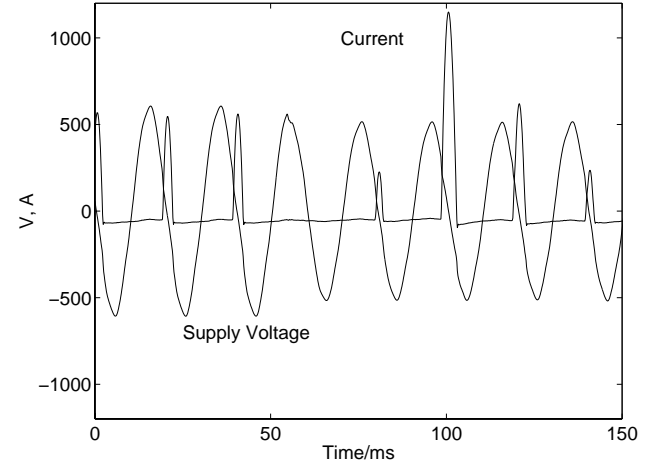
Figure 6. Induction Motor Heater Current and Supply Voltage during a Sag

heating units is apparent when a voltage sag occurs (as shown in Figure 6). The relatively small voltage reduction of 15% causes a large transient excursion with a peak of 1200A along with one missed conduction cycle.

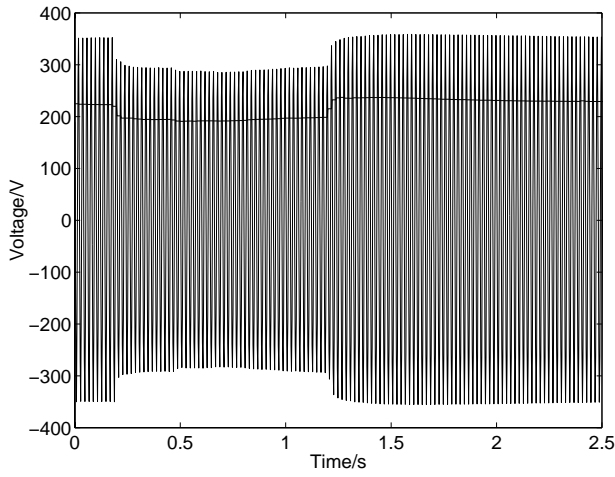
Figure 7. Sag Example 1 (Instantaneous and RMS Voltage)

A large number of sags that have been recorded at the site cannot be correlated with events internal to the site. These sags vary in magnitude and duration. No statistical analysis is covered in this paper but the voltages during two sag events are shown in Figure 7 and Figure 8. The clearing times of the faults that caused these sags show that the faults occurred on the 50kV or the 11kV network. Correlation studies between faults on the transmission network and the sags measured at the monitored point show faults on the high voltage 110kV transmission network appear relatively infrequently as the cause of sags at the monitored site.

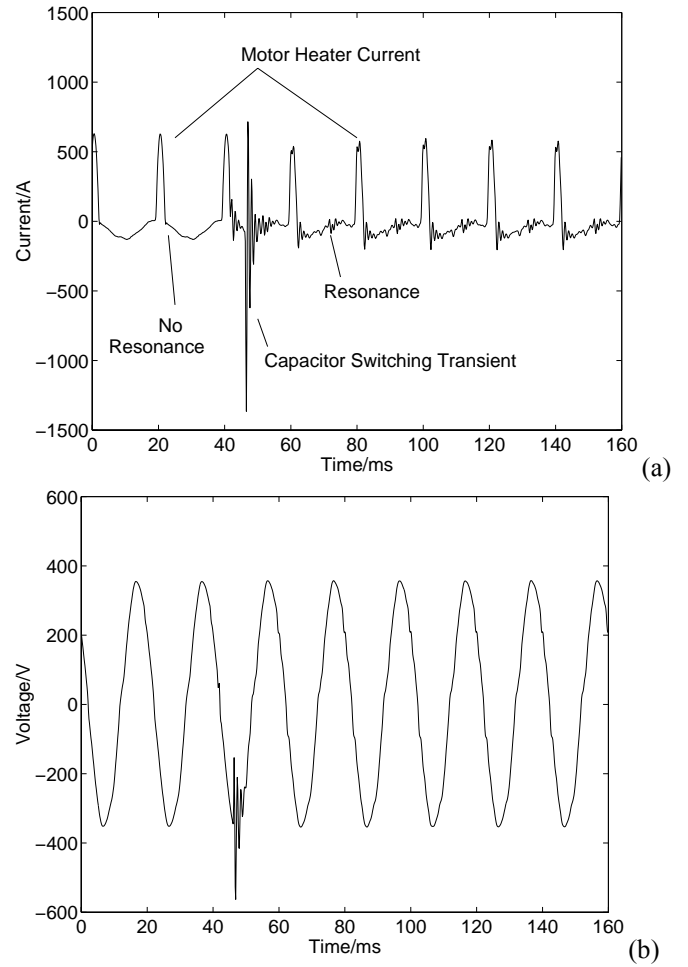
Figure 9. Capacitor Switching Transient (a) Current (b) Voltage

Power factor correction capacitor banks are switched to maintain close to unity power factor because the supply company's conditions of supply are such that VA demand is not a consideration as long as the power factor is unity. The supply company have mobile power factor loggers that are rotated through their industrial customers' sites on a regular basis to ensure compliance. The displacement power factor at the site is almost unity at all times except under very low load levels. A power factor correction capacitor switching event is shown in Figure 9. The initial switching transient is large with a 1400A peak. The transient disturbance is also apparent from the voltage waveform where the peak phase to neutral voltage reaches almost 600V. This transient is quickly damped away but a resonance now occurs which can be seen in the current in Figure 9(a).

The capacitor switching and the associated resonance indicate that the AC system is not well damped, which is consistent with the loading figures for the system. The resonance could be damped with a harmonic filter tuned to the resonant

frequency or the power factor correction capacitor banks could be tuned by adding series inductors. As these solutions are expensive it is unlikely they will be adopted and the lack of reported problems means that no solution is required.
